Next generation slip ring motors

Technical information

Technical information from VEM Sachsenwerk GmbH

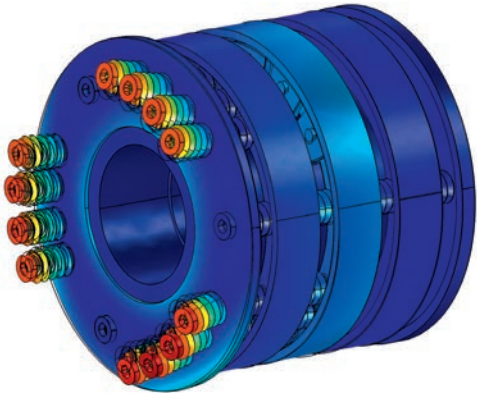
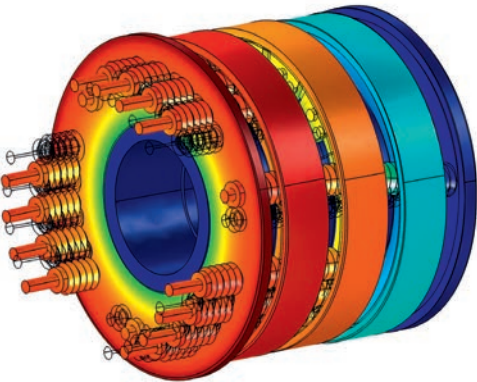
FE-Simulation of loads on slip ring: centrifugal forces (left) and torque (right)

Increased external forces, e.g. from a faulty starter procedure, can cause internal movement between slip ring parts, leading to increasing looseness of the assembly. Once the mechanical looseness is initiated, the mechanical slip ring assembly will be subject to an accelerated destruction process.

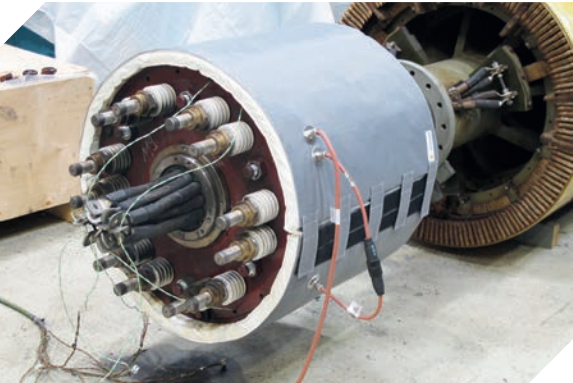
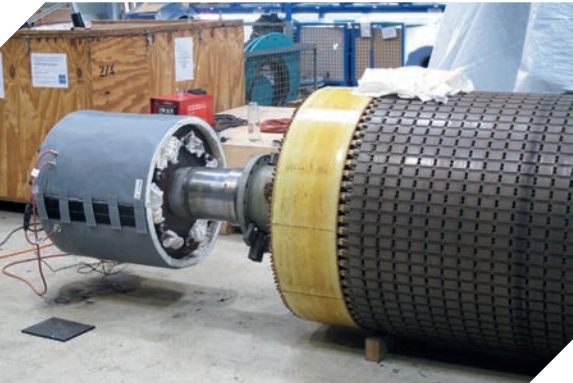
Mobile heating blanket for temperature procedure during slip ring refurbishment

Old slip rings can be refurbished on site if the rotor is outside the stator. Refurbishing instructions lead the engineer through all individual steps. They are available at VEM and cover the following steps:

- Disassembly of connectors
- Application of a heating blanket to perform the temperature procedure
- Tightening of stability and electric current bolts in hot condition
- Cool-down of slip ring
- Adding pins for additional torque transmission between hub and floating disc
- Re-assembly of connectors
- Machining of slip ring surface

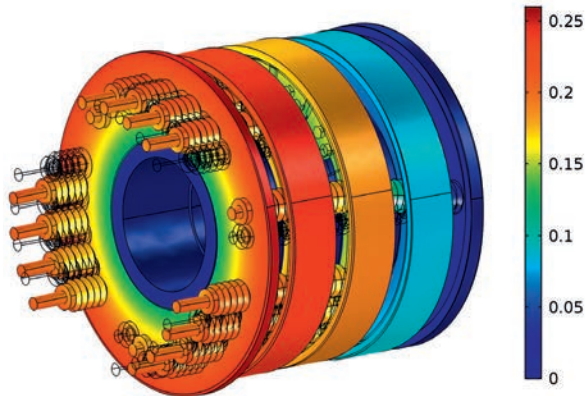
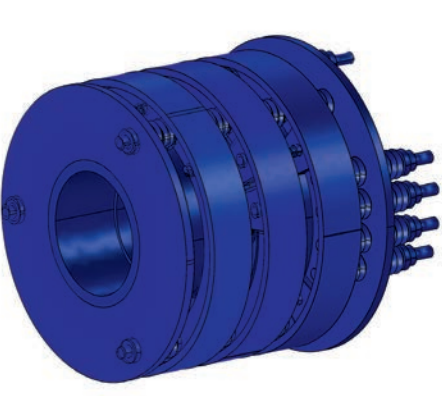
Reduced tangential movement on torque load (old on left, new on right) due to switching of the fixed and floating disc (finite element simulation)

- Old: Only “mechanical stability bolts” clamp the slip rings parts together
- New: Increased bolt forces for the “mechanical stability bolts” enhance the internal forces
- Old: “Electrical current bolts” made from copper were used for electrical purposes only
- New: “Electrical current bolts” now contribute significantly to mechanical clamping forces
- New: Special “temperature procedure” during slip ring manufacturing simulates the thermal aging of isolating discs – extended mechanical lifetime
- Change of force transmission path from the slip ring hub to the slip rings and bolts (switching of floating and fixed disc on hub). Forces from torque shocks (e.g. faulty start procedure) are now transferred directly to accelerate the heavy current bolts. Less internal movement!

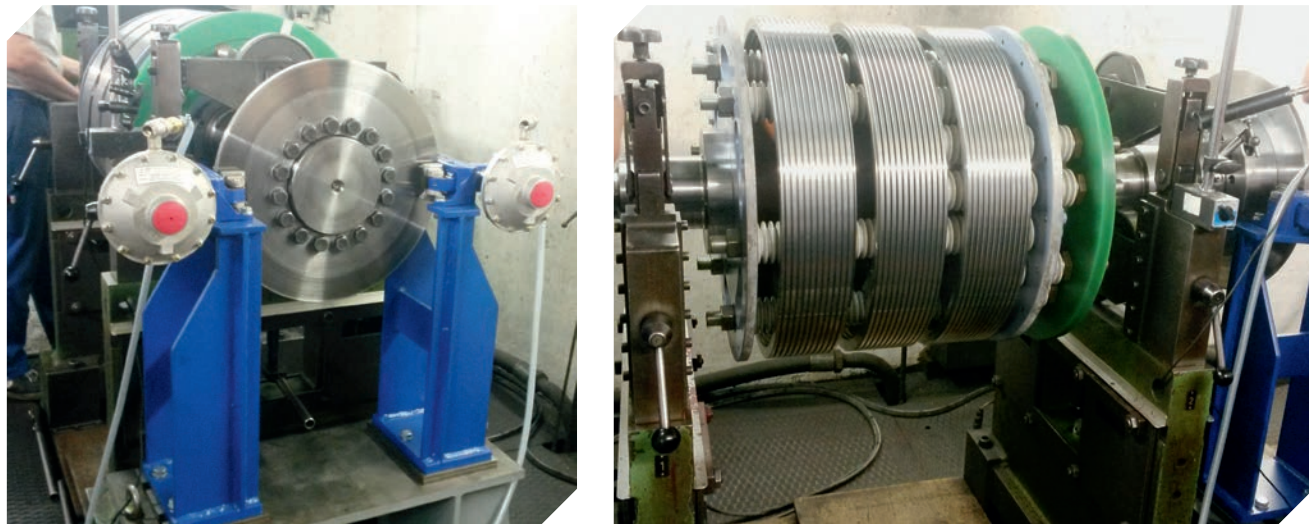
To prove the success of increased mechanical stability, hardware tests were performed wherein old and new slip rings were exposed to severe mechanical loads. VEM used a disc brake in a test facility for extreme torsional loading. Slip rings were decelerated from 1 800 rpm to 0 rpm within 1 second!

Disc brake in test facility for extreme torsional loading of slip rings

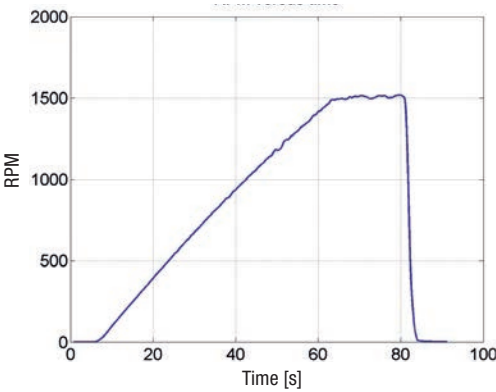
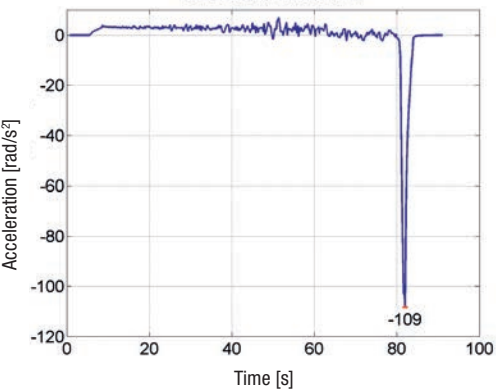
Rotational speed (left) and acceleration over time (right) during slip ring tests

All slip rings delivered from 2016 incorporate the afore-mentioned modifications. So far, no customer complaints are known. All possible tests, as well as initial customer feedback, have been able to prove the improved mechanical behaviour of the new slip rings.

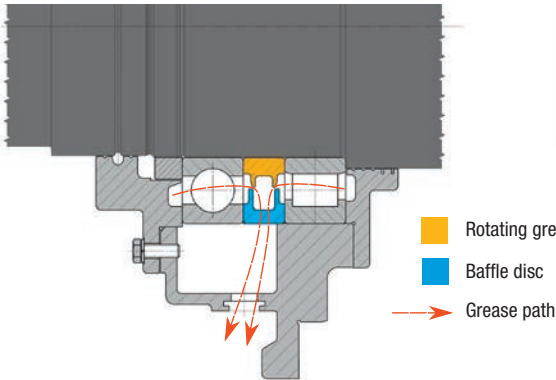
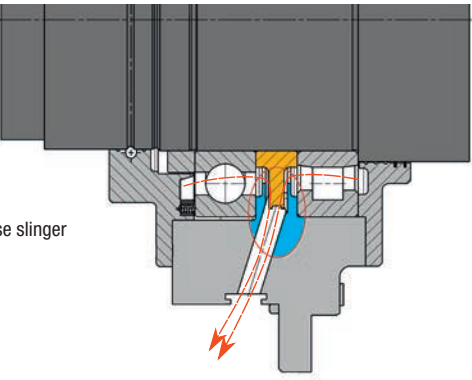
Core of the new concept is the radially extended rotating grease slinger disc to actively transport the old grease from bearing head into the old grease container. The baffle plate is separated into two parts to allow radial overlap with the rotating grease slinger. The radial extension of the rotating grease slinger provides radial acceleration of old grease which contacts the slinger disc. Any old grease accumulation or pressure will be avoided by this simple modification.

Radially extended rotating grease slinger is core of the new bearing lubrication concept

The new old grease concept can easily be retrofitted into existing motors with minimum effort. For most machines, new bearing heads could be delivered at the customer's request. In addition to the old grease removal concept, new bearing heads would automatically introduce other positive modification made to VEM large-drive bearing heads since 2011. With this concept, VEM is confident that it can offer a significant upgrade for your motor reliability in respect to one of the most sensitive topics.

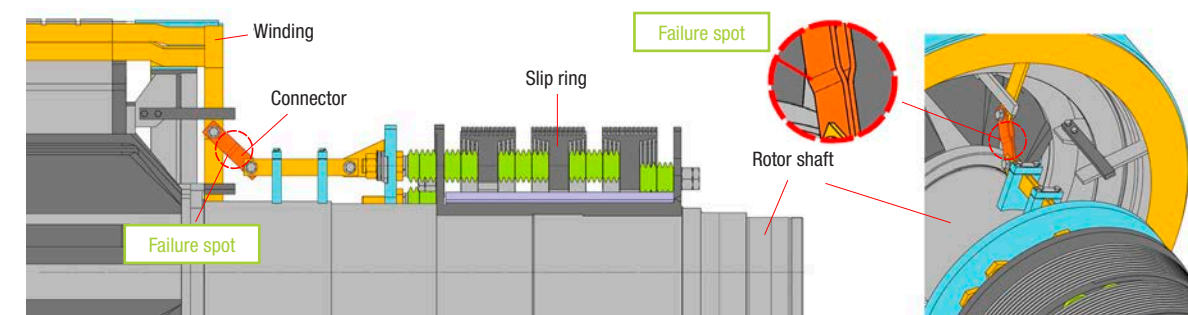
- Winding head movement in radial direction caused by centrifugal forces pulling on connector
- Rigid connection of connector bar on rotor shaft
- Large number of motor starts amplifies possible fatigue issue
- Elbowed connector design in 45° part with notches which concentrate mechanical stress at indicated failure point

Coincidence of the aforementioned factors leads to mechanical fatigue at the indicated failure spot.

Position of elbowed connector bar between slip ring and rotor winding

- The elbowed 45° connector bars can be replaced with straight bars to avoid notch stress.
