Next generation slip ring motors

Technical information

Technical information from VEM Sachsenwerk GmbH

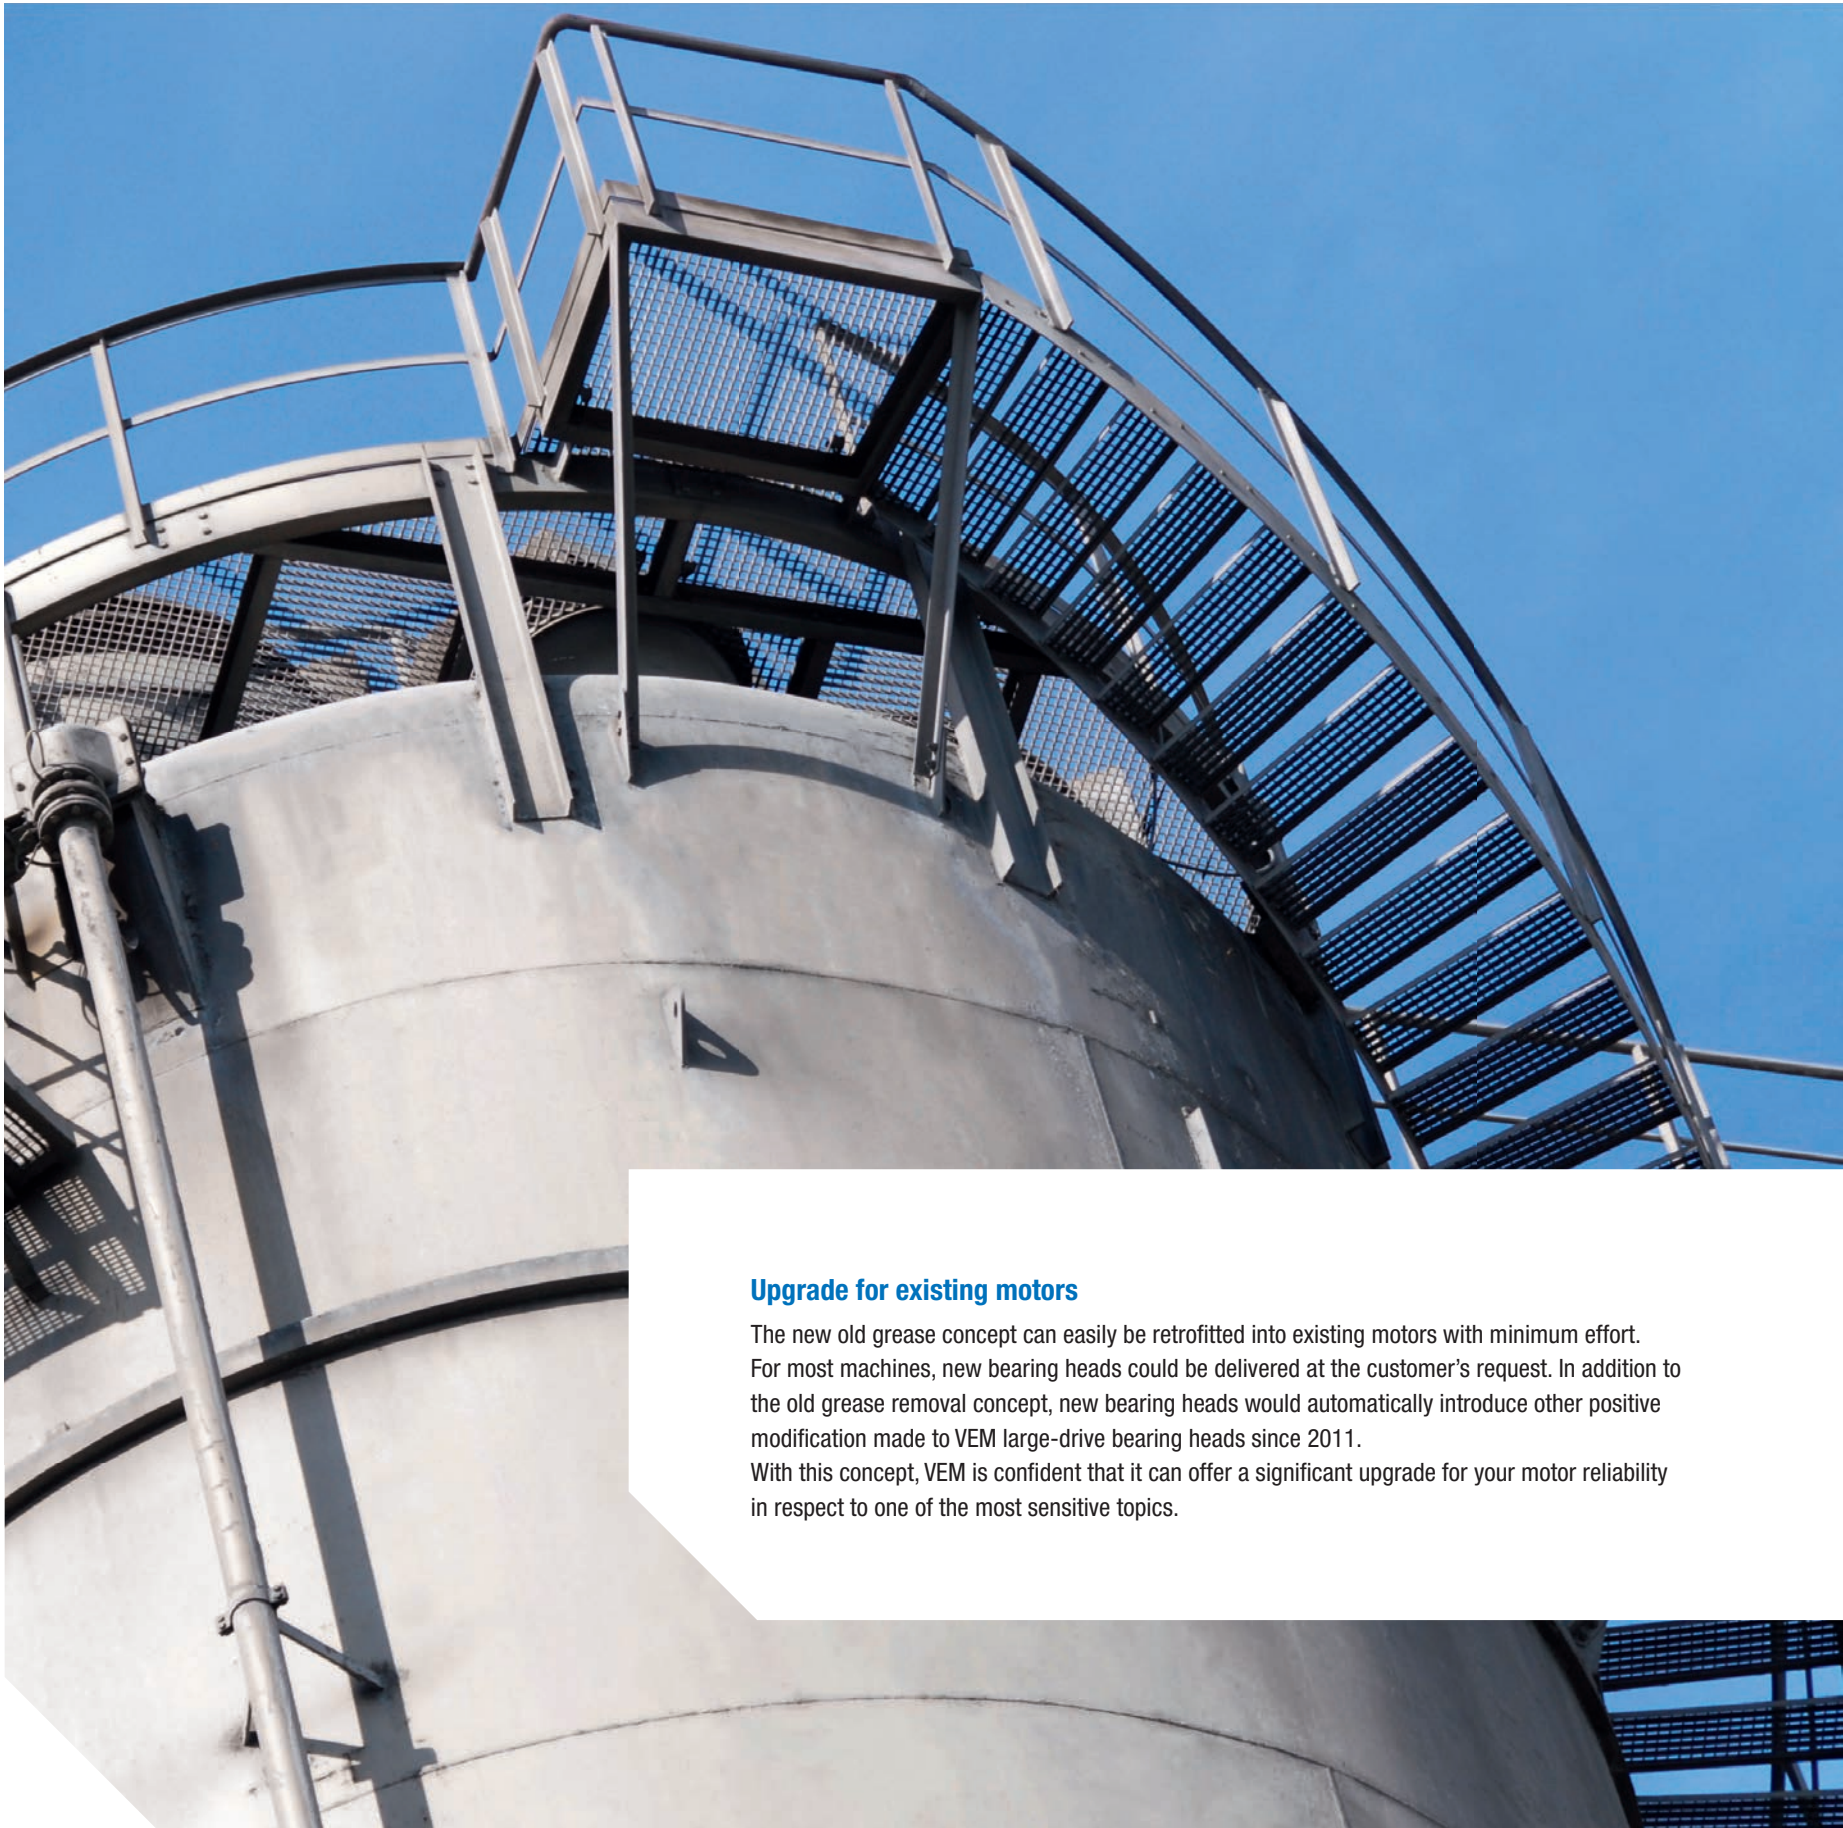
Rotating grease slinger
Baffle disc
Grease path

Radially extended rotating grease slinger is core of the new bearing lubrication concept

The new old grease concept can easily be retrofitted into existing motors with minimum effort. For most machines, new bearing heads could be delivered at the customer's request. In addition to the old grease removal concept, new bearing heads would automatically introduce other positive modification made to VEM large-drive bearing heads since 2011. With this concept, VEM is confident that it can offer a significant upgrade for your motor reliability in respect to one of the most sensitive topics.
